Section 2

Changes to the Building Exterior

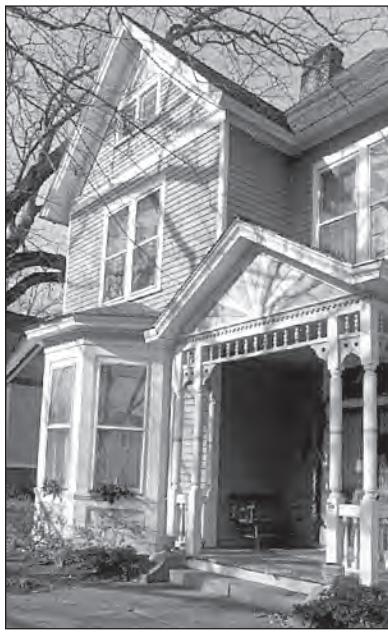
Turned spindles and columns, pierced brackets, and a radiating pattern of flush boards in the porch gable of this clapboard house illustrate the versatility of wood for detailing.

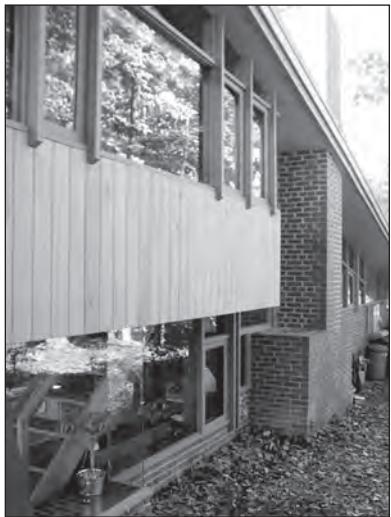
The vertical lines of the stained board siding and projecting wood window mullions give this mid-century home a distinctly modern look.

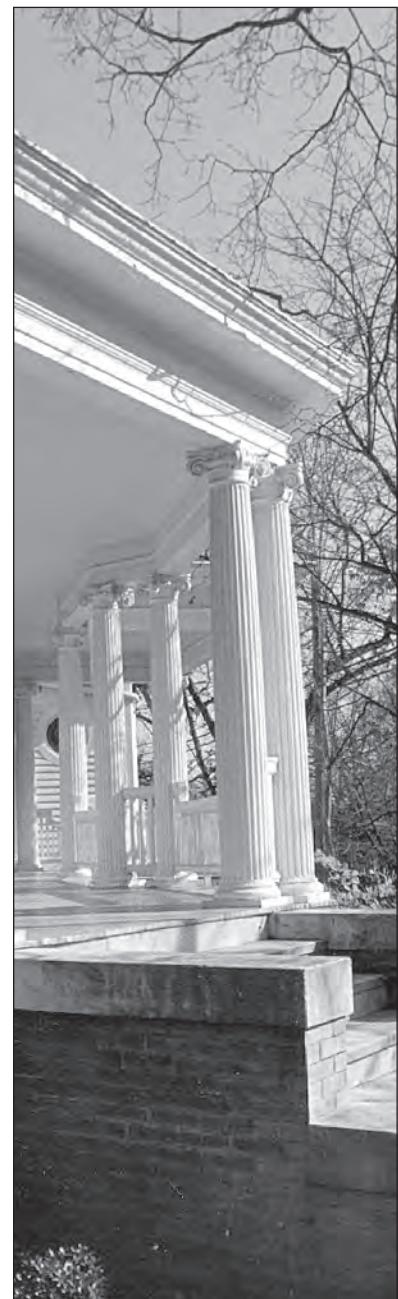
Regular maintenance of exterior wooden columns is critical to prevent the need for expensive repairs or replacement in the future.

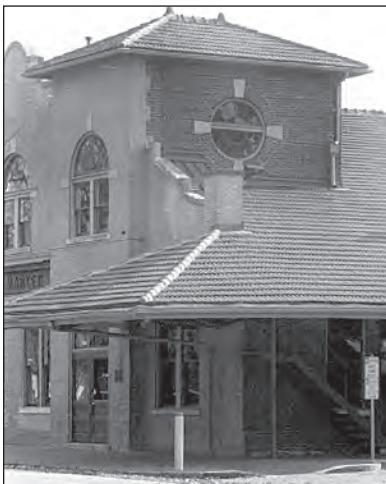
A prominent feature of the Mission-style City Market is its distinctive clay tile roof.

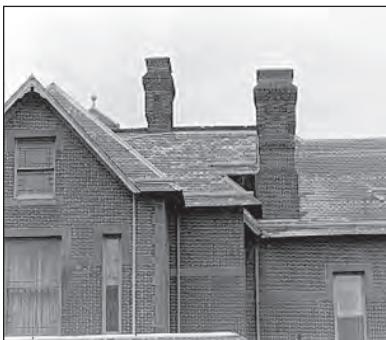
The corbelled brick chimneys, patterned slate roof, and brick exterior walls with stone quoins at the corners are all significant masonry features of the Executive Mansion.

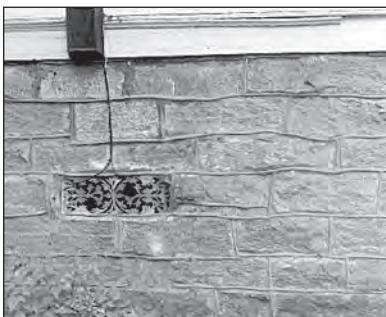
A granite foundation with beaded mortar joints adds distinction to this residential foundation.

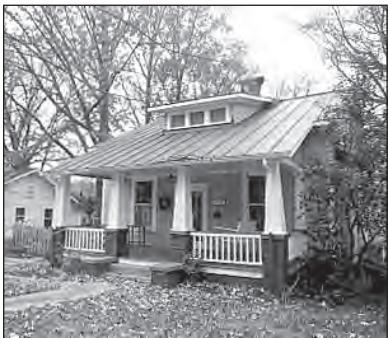
Standing-seam terneplate roofs are quite common in the residential districts.

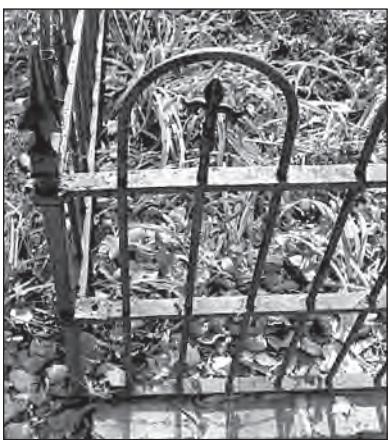
The paint film on this cast-iron fence is failing because of corrosion. All rust must be removed before repainting.

Cleaning hard metals, such as cast or wrought iron and steel, is best accomplished by hand scraping or wire brushing to remove any corrosion before repainting. In extreme cases a low-pressure (80–100 lbs. per square inch) glass bead abrasive cleaning may be necessary if wire brushing has proven ineffective. Patching or replacing deteriorated metal in kind is always preferable to using substitute materials. Corrosion due to galvanic reaction between dissimilar metals limits the options of patching one metal with another. If a detail of a painted metal feature such as a decorative cornice is missing or deteriorated, replacement in kind may not be feasible, and the replication of the detail in fiberglass, wood, or aluminum may be appropriate. Asphalt products such as roofing tar corrode metals and should never be used to patch flashing or other metal surfaces.

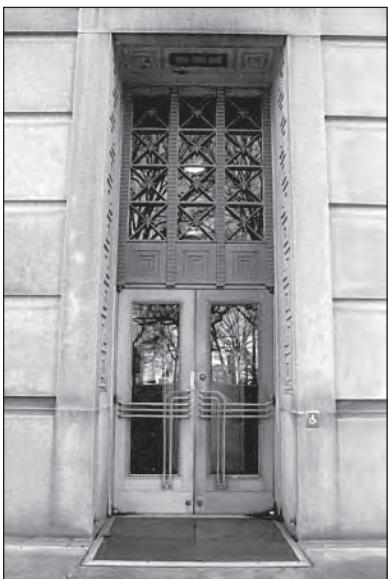
The architectural significance of the decorative metal work on the front entrances to the Justice Building warranted automating this pair of steel doors rather than replacing them to meet accessibility requirements.

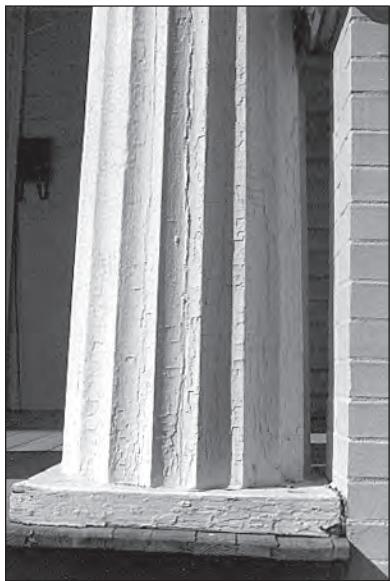
When multiple layers of paint begin to check and alligator, as this column's surface has, they must be scraped and sanded down to the first sound paint film layer before repainting.

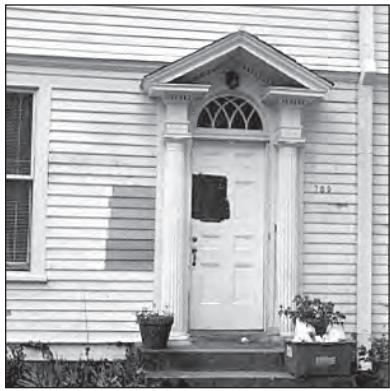
In selecting new paint colors for this residence, test areas of proposed colors were applied to the facade for viewing.

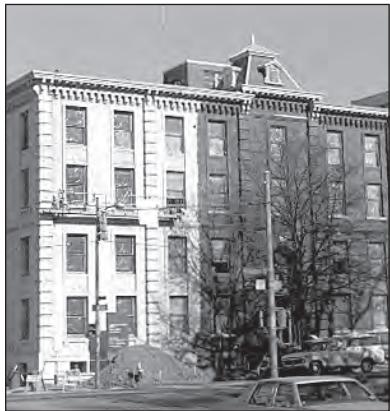
Layers of paint were successfully chemically stripped from the Labor Building's facades during a major rehabilitation.

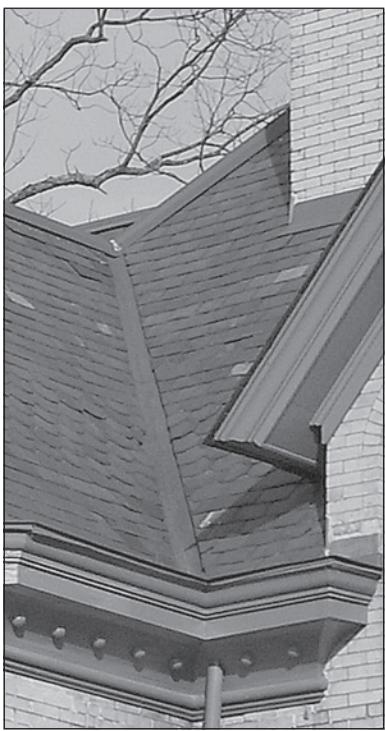
This well-maintained slate roof includes valleys and crestings that have a sound paint film protecting them from corrosion.

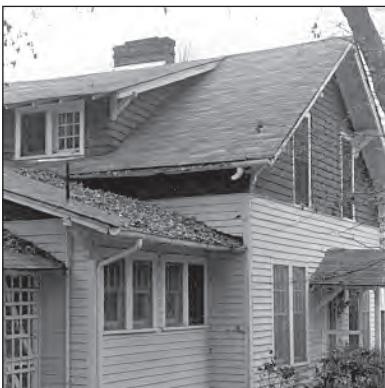
A missing downspout from the main gable and a large collection of fallen leaves will accelerate the deterioration of the shingles on the rear gable of this roof.

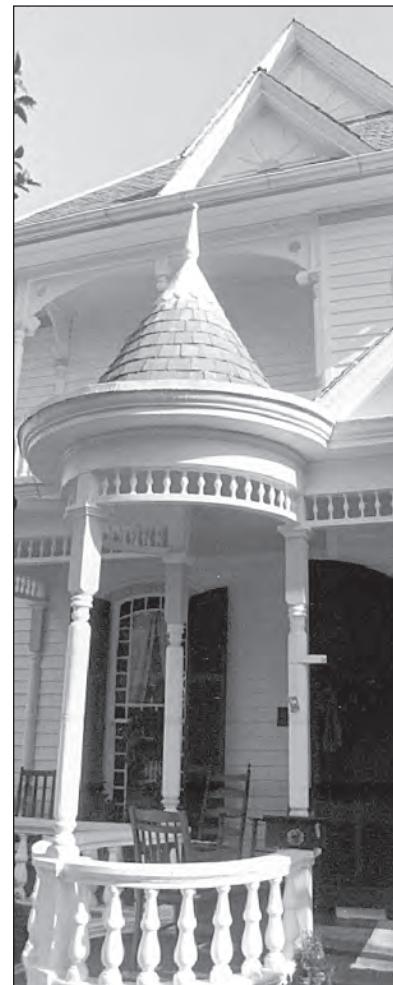
A finial adds a distinctive accent to the top of this conical roof while protecting the peak from water penetration.

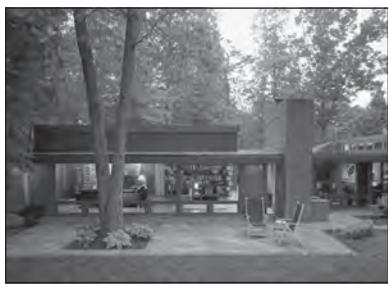
The large expanses of glass framed in wood in this landmark early modernist house create a strong connection between the interior and the backyard patio. The massive brick chimney wall visually anchors the glazed exterior walls on either side.

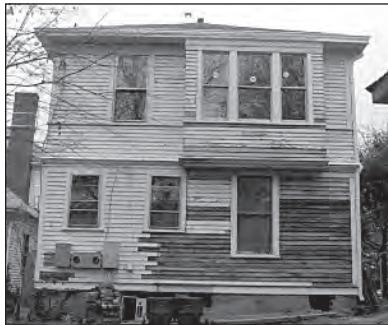
During rehabilitation, replacement siding to match the original siding was carefully incorporated on this rear facade before repainting.

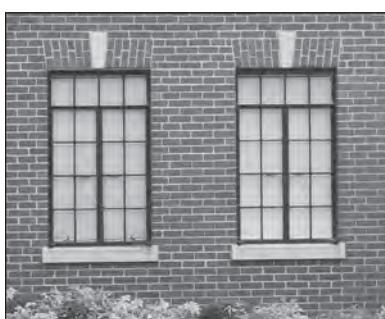
Rolled steel casement windows are hinged vertically and are distinctive features found on many buildings from the 1920s and 30s.

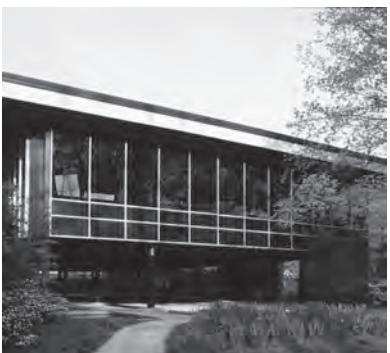
The curtain wall facade of this Raleigh landmark is characteristic of many mid-century modern office buildings which embraced large spans of non-loadbearing glass walls.

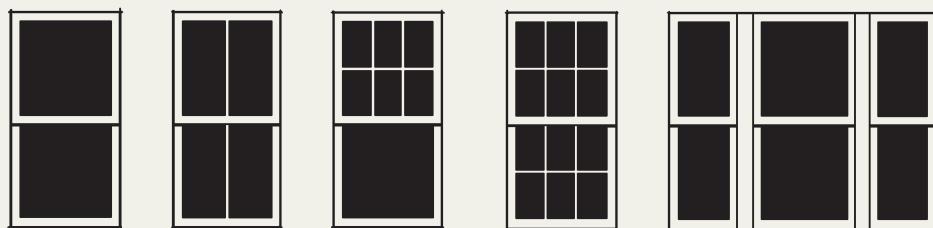
1 over 1

2 over 2

6 over 6

Composite window

In the early districts, vertically proportioned wooden windows with operable double-hung sashes are quite common. The sashes are often subdivided into smaller panes, or lights.

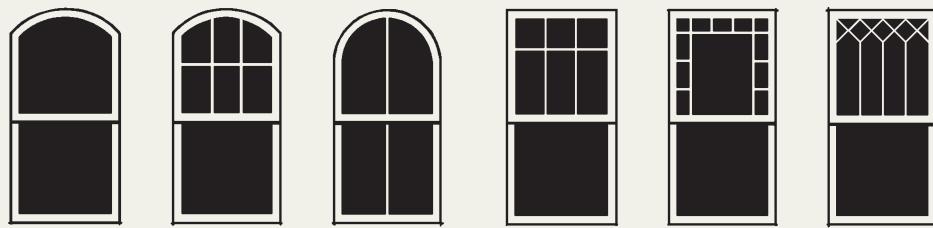
Arched upper sashes

Sashes with geometric tracery

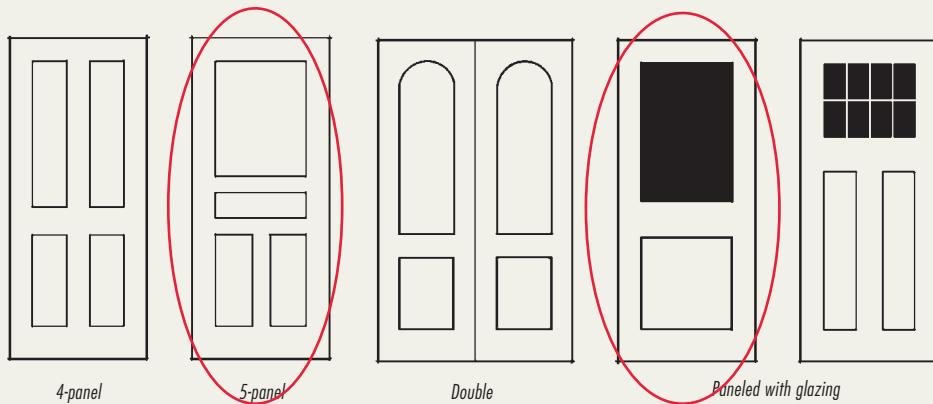
4-panel

5-panel

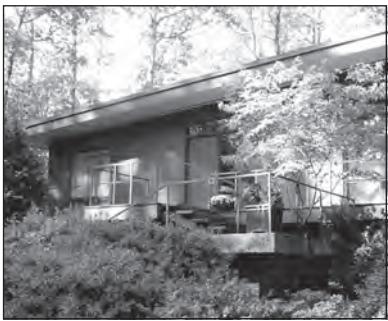
The raised front entrance to this modernist home continues across the front of the house as a narrow cantilevered deck partially sheltered by the roof overhang.

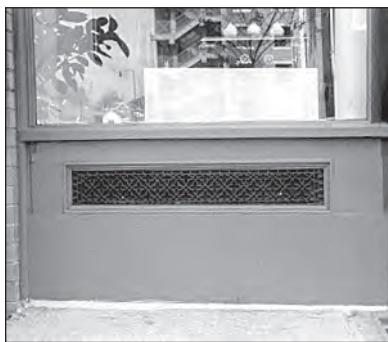
The cast-iron grille recessed within this storefront bulkhead panel is both decorative and functional.

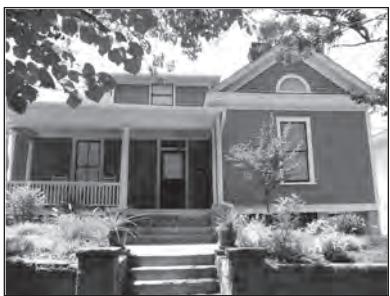
During the summer, dormers with operable windows and louvered gable vents can help cool a house by allowing rising hot air to escape.

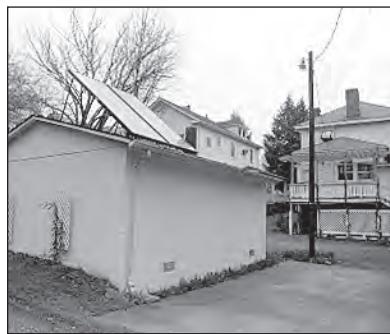
These solar collector panels are located on the roof of an inconspicuous accessory building at the rear of the property.

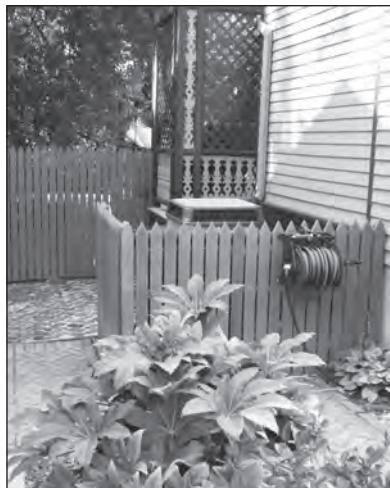
This mechanical unit was installed on a rear side facade and further screened from view by a low, wooden picket fence and foundation plantings.

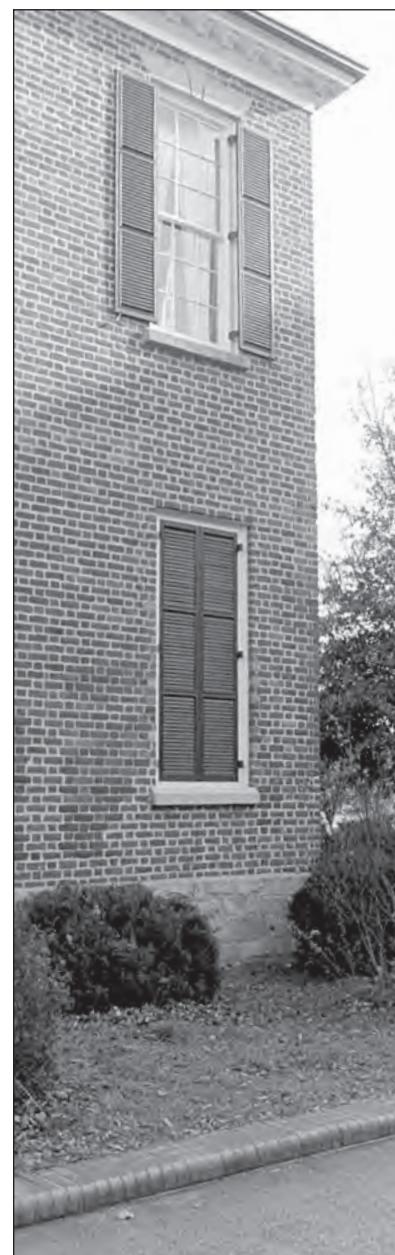
Louvered shutters provide a traditional means of shading the sun's heat from the interior of a structure while providing ventilation.

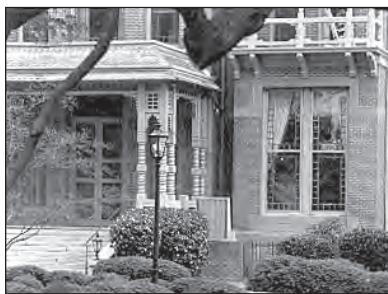
A mechanical lift provides access to the entrance of the Executive Mansion from the right side of the front porch. The lift itself is partially screened by the foundation plantings.

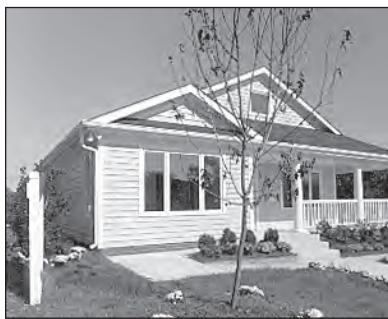
A universal design residence in the Oakwood district provides access to the front porch both by steps and by ramp.

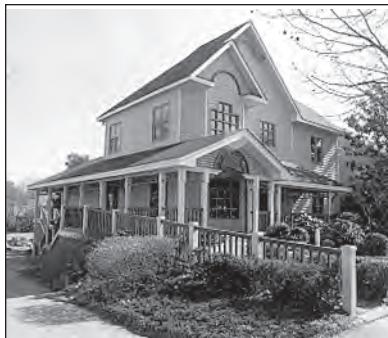
Both the use of traditional materials and details and the addition of landscape screening successfully integrate this ramp with the building and its site.

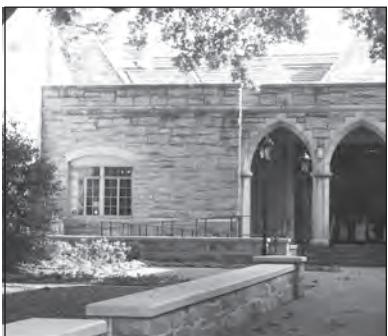
Only the metal railings of the ramp added in this church courtyard are visible above the low stone wall that edges the landscaping.

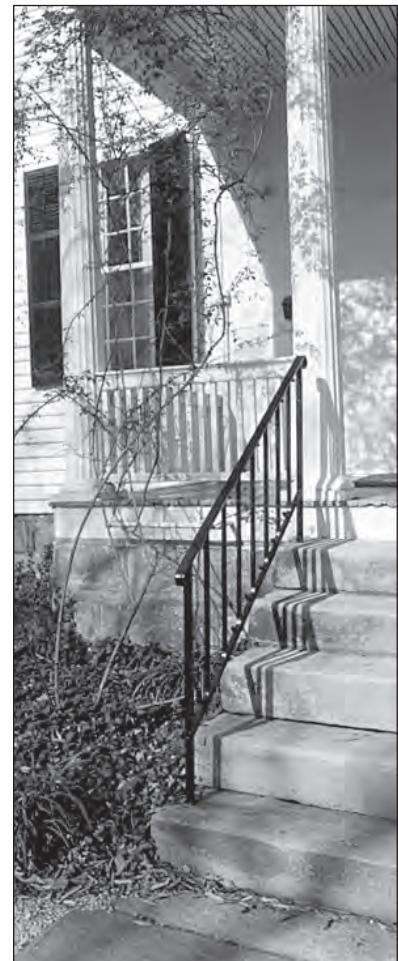
This discrete black handrail provides a safe edge for a steep entry stair.
