3.9 Storefronts

3.10 Utilities and Energy Retrofit

3.11 Accessibility, Health, and Safety Considerations

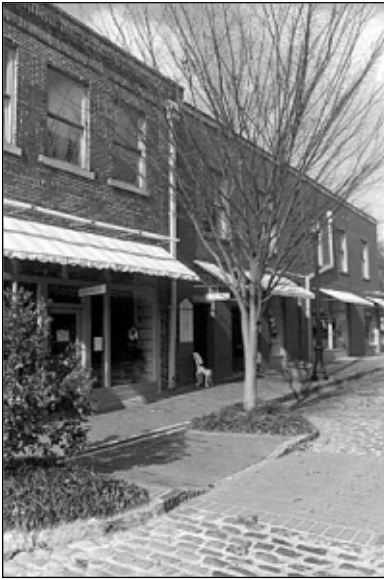
A unifying facade rhythm is created by the pattern of recessed entries, display windows, and projecting awnings of these sensitively rehabilitated storefronts.

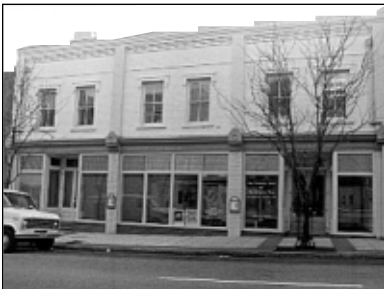
The storefront bays with their decorative mid-cornices and bands of glazed transom panels contribute to the architectural character of this Hargett Street commercial building.

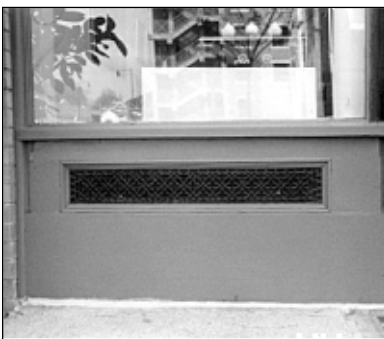
The cast-iron grille recessed within this storefront bulkhead panel is both decorative and functional.

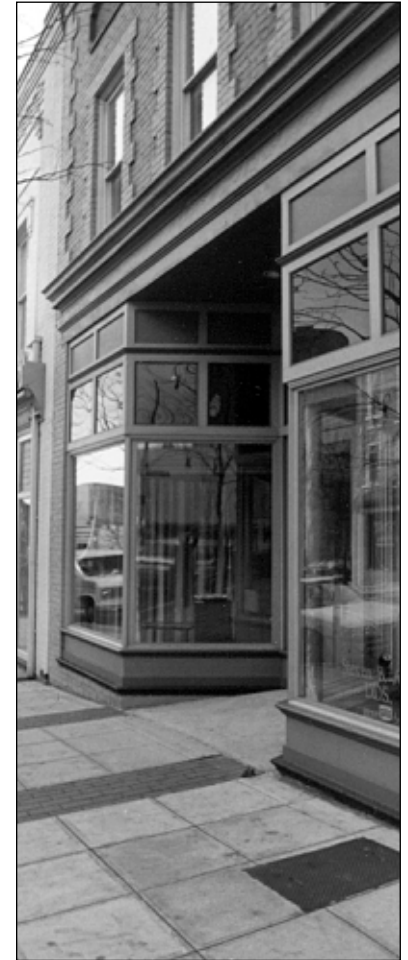
This replacement storefront design is compatible with the building in its scale, size, materials, and colors.

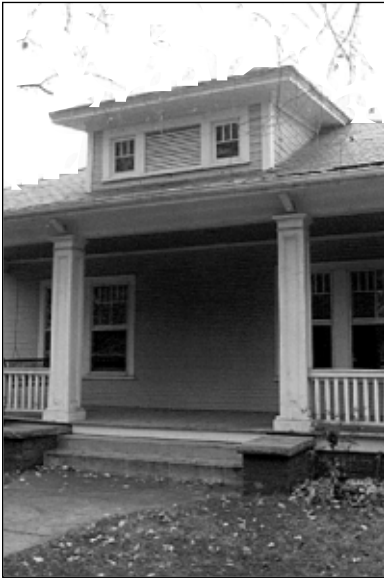
During the summer, attic dormers like this one with operable windows and a louvered vent panel can help cool a house by allowing rising hot air to escape.

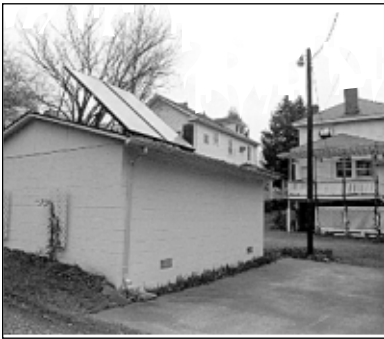
These solar collector panels are inconspicuously located on the roof of an accessory building at the rear of the property.

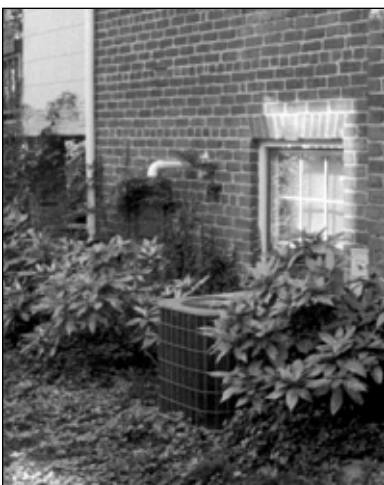
This mechanical unit was installed on a rear side facade and further screened from view by foundation plantings.

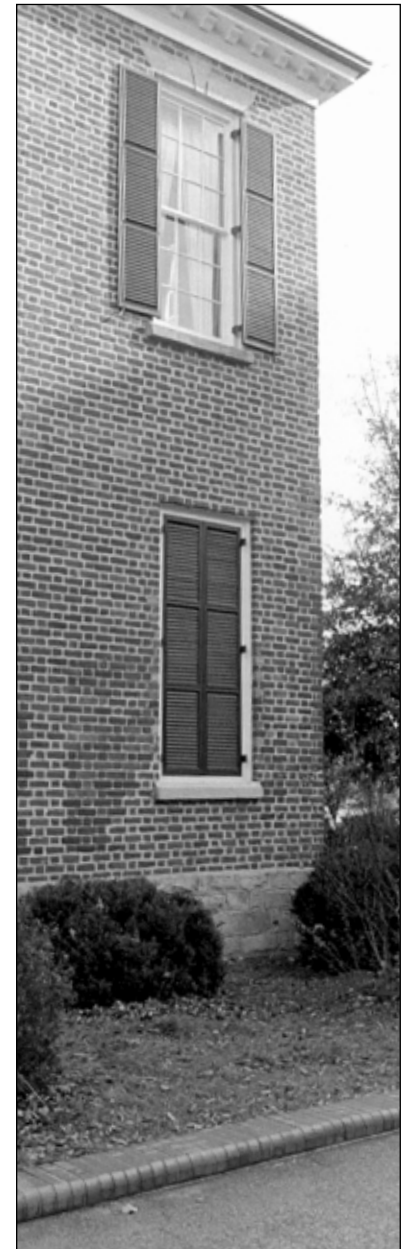
Louvered blinds provide a traditional means of shading the sun's heat from the interior of a structure while allowing ventilation.

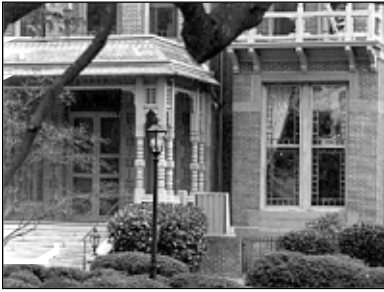
A mechanical lift provides access to the entrance of the Executive Mansion from the right side of the front porch. The lift itself is partially screened by the foundation plantings.

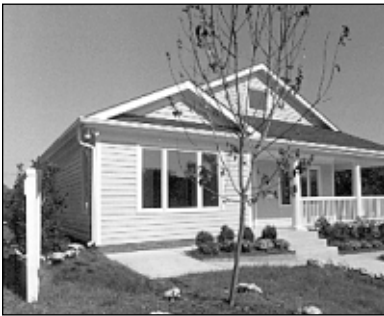
A universal design residence in the Oakwood district provides access to the front porch both by steps and by ramp.

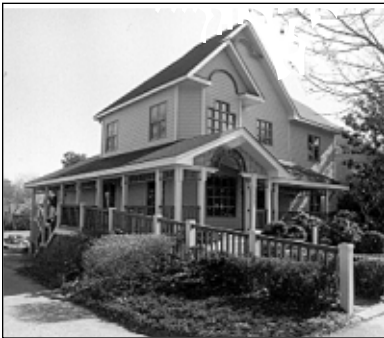
Both the use of traditional materials and details and the addition of landscape screening successfully integrate this ramp with the building and its site.

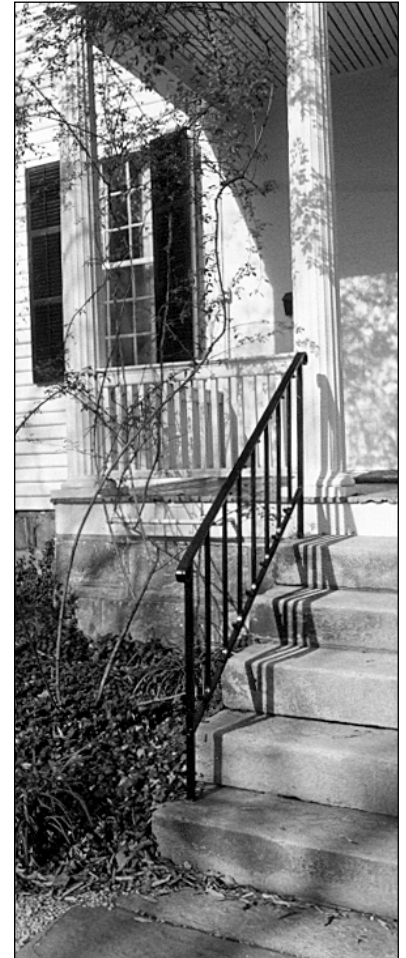
This discrete black handrail provides a safe edge for a steep entry stair.
